CASE STUDY

PROJECT:
Apartment Complex

INSTALLATION TYPE:
Hydronic HVAC Repipe

Corzan® CPVC Expert Repipes Air Conditioner in Record Time

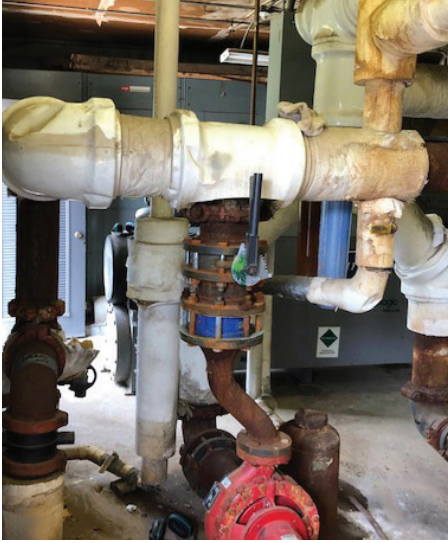
A complete repipe from the mechanical room to the fan coil units was long overdue.

Under its previous ownership, preventive maintenance was virtually nonexistent for the 10-building complex's HVAC infrastructure. The steel system in each building—two chillers and two boilers—dated back to 1976. Leaks had been “remedied” with compression fittings, bicycle inner tubes and pipe clamps. The fan coils were degraded and clearly failing. A complete repipe from the mechanical room to the fan coil units for all 240 apartments and the laundry facilities was long overdue.

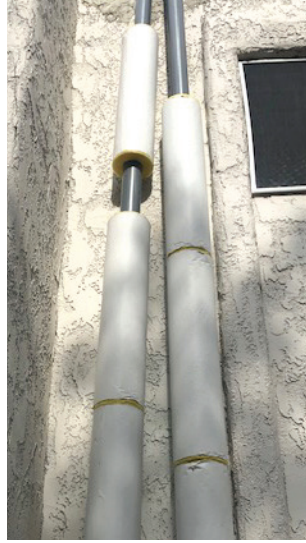
Leveraging the expertise of Integrity Plumbing's senior techs, test stacks of the two-story structure were created to validate the piping route that could bypass the ceilings.

- New leaks to the old system almost daily as the crew ran pipe parallel while making roof penetrations through the floor joists, causing vibration.
- Discovery of asbestos in the popcorn ceilings of the buildings, adding a \$500,000 abatement price tag (not counting labor) to the project in the event the ceilings were disturbed. Leveraging the expertise of their senior techs, test stacks of the two-story structure were created to validate the piping route that could bypass the ceilings altogether.

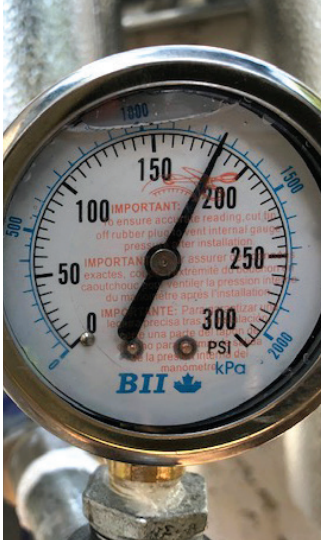
The solvent welded joints were pressure tested to 190 psi.

- The critical nature of the chamfering and deburring step. Corzan CPVC pros know that it's essential to slightly bevel and ream the outside and the inside of the pipe to remove burrs and CPVC shavings so that it can be eased into the socket without pushing the solvent cement into the joint. In fact Arizona Integrity Plumbing's crews use a custom deburring tool connected to their power tools to ensure this step is not missed.
- The importance of quarter-turning the pipe into the fitting to evenly spread the solvent holding it in place, preventing pipe pushout and ensuring a solid bond.
- The need to allow the joint to set for two hours and complete pressure testing to 190 psi.
